Robotic Bioshield Repair - A Diakont Success Story

Fuel Guide Tube Repair - A Diakont Success Story

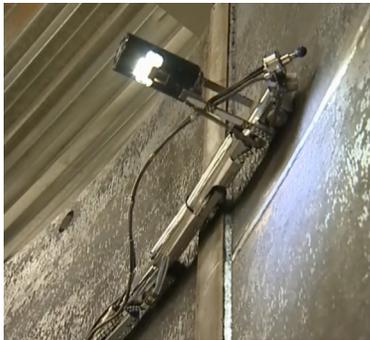
Remote Grinding Robot

Diakont designed and manufactured a remote, self-propelled robotic system to diagnose the damage and repair the bio-shield. The advanced system is based on a "snake-like" form factor and has a magnetic chassis to adhere to the metallic wall and traverse the entire surface area of the bio-shield. This robot was outfitted with three modular payloads to perform distinct, role-specific tasks: inspection, surface preparation grinding, and welding.

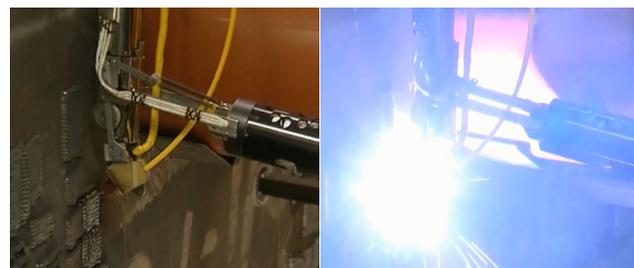
Remote Welding Robot

Diakont's custom robotic solution was deployed through the narrow 2" opening in the bio-shield wall and successfully located the damaged areas using high-resolution video and ultrasonic testing (UT) probes. Next, Diakont dispatched the robot with the grinding tool to prep the surface for a weld repair. Finally, the robot was sent into the bio-shield with the weld head, where it successfully repaired the damage.
