Online Storage Tank Floor Inspection Services

- API 653 tank floor inspection service for filled tanks
- Eliminate unnecessary tank turnarounds
- Complete coverage analyzed in real time
- Certified explosion-proof to Class 1, Div 1

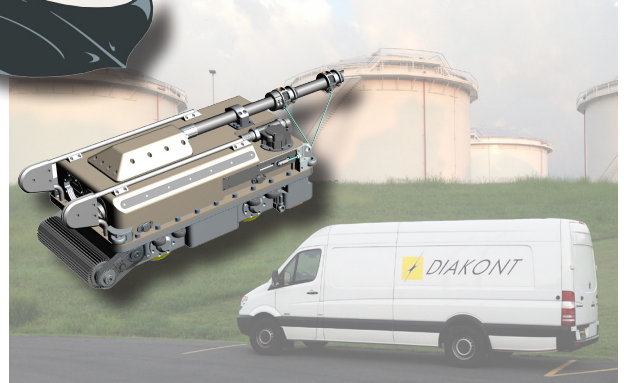
STINGRAY

Stingray inspection systems are equipped with water jets and power scrubbers to clear tank floor sludge and sediment, allowing the onboard magnetic flux leakage (MFL) and an array of ultrasonic testing (UT) sensors to capture high accuracy integrity data. Stingray systems are also equipped with advanced navigation modules that use 3D sonar imaging for mapping their location within the tank.

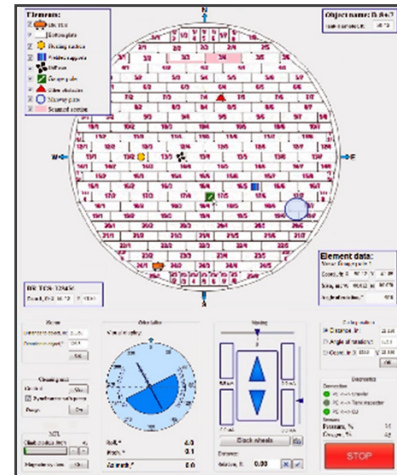
Complete tank floor map generated in real-time

- Magnetic flux leakage (MFL) – High resolution sensors for detecting anomalies
- Ultrasonic testing (UT) - High accuracy sensors for collecting floor thickness measurements and sizing anomalies
- 3D sonar imaging - XYZ scans of tank floor and internals for mapping and navigation
